MARINE INVESTIGATION REPORT
M17P0052

Capsizing and sinking with loss of life

Fishing vessel *Miss Cory*
Strait of Georgia, British Columbia
06 March 2017

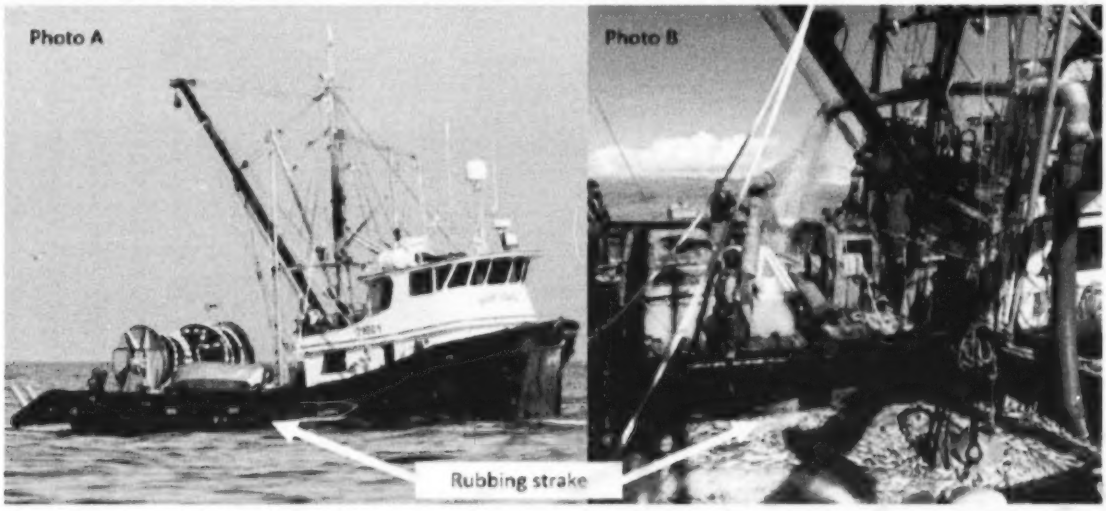
Figure 3. The rubbing strake on the Miss Cory, shown above the surface of the water while the vessel is voyaging (Photo A) and submerged while the vessel lists during operations (Photo B)

A delay in the availability of a packing vessel resulted in a large set of fish being tightly pursed in the seine along the *Miss Cory*'s starboard side for several hours. Unable to swim freely, many of the fish died, and as they sank and settled to the bottom of the pursed seine, their weight increased the load on the net. The load transferred to the starboard side of the *Miss Cory* and to the top of the boom, raising the vessel's centre of gravity and causing the vessel to increasingly list to starboard. This, together with a reduced freeboard caused by loading the forward holds, resulted in the vessel listing to the point where the rubbing strake was submerged in water.

2. The increased load caused the vessel to list, submerging the rubbing strake.

3. Seawater likely leaked into the vessel's hull from behind the rubbing strake and made its way through the skin of the hull and into the shaft tunnel.

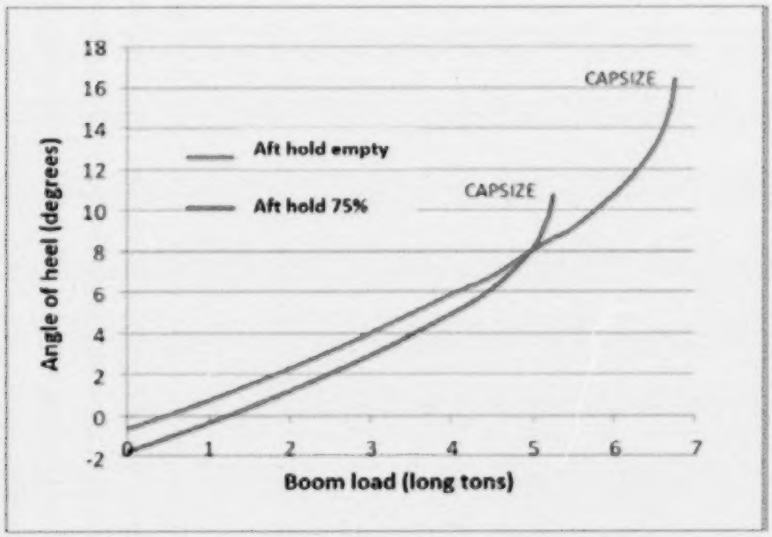
Figure 5. Limit of boom load (Image: MerLion Marine Services, with TSB annotations)

With the given parameters, it was calculated that the vessel would capsize at a boom load of 6.76 long tons with the aft hold empty, and at a boom load of 5.26 long tons with the aft hold 75% full. Figure 5 shows the angle of heel with increasing boom loads for the 2 conditions.

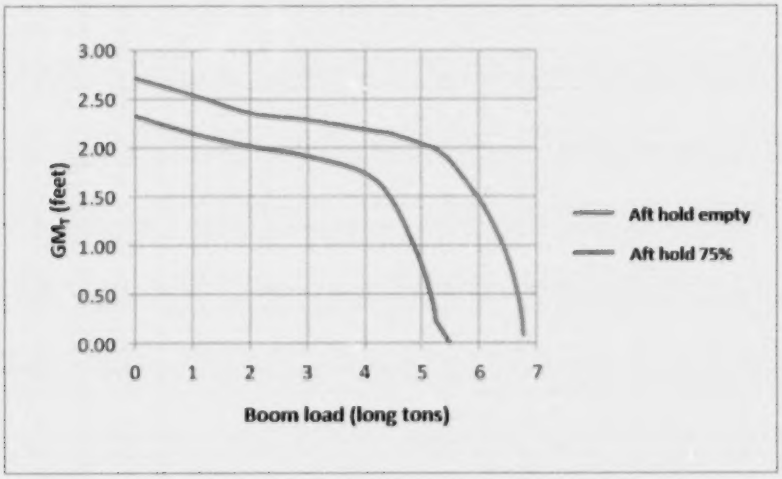
As the boom load increases, the value of the transverse metacentric height (GM_T)[30] decreases in a virtually linear fashion until a certain point is reached, at which point the GM_T decreases exponentially (Figure 6).

Figure 6. Transverse metacentric height (GM_T) with increasing boom load (Image: MerLion Marine Services, with TSB annotations)
